Contract #: 04-0120F4Cty: SF/ALA Rte: 80 PM: 13.2/13.9File #: 69.28**WELDING INSPECTION REPORT****Resident Engineer:** Pursell, Gary**Address:** 333 Burma Road**City:** Oakland, CA 94607**Report No:** WIR-000715**Date Inspected:** 29-Oct-2007**Project Name:** SAS Superstructure**OSM Arrival Time:** 630**Prime Contractor:** American Bridge/Fluor Enterprises, a JV**OSM Departure Time:** 1530**Contractor:** Zhenhua Port Machinery Company, Ltd (ZPMC), Changxing Island **Location:** Changxing Island**CWI Name:** Art Peterson**CWI Present:** Yes No**Inspected CWI report:** Yes No N/A**Rod Oven in Use:** Yes No N/A**Electrode to specification:** Yes No N/A**Weld Procedures Followed:** Yes No N/A**Qualified Welders:** Yes No N/A**Verified Joint Fit-up:** Yes No N/A**Approved Drawings:** Yes No N/A**Approved WPS:** Yes No N/A**Delayed / Cancelled:** Yes No N/A**Bridge No:** 34-0006**Component:** OBG Closed Ribs**Summary of Items Observed:**

Caltrans Quality Assurance (QA) Inspector, Larry Viars was present to observe the dimensional testing of Orthotropic Box Girder (OBG) 10 Meter closed rib weld trial, for the San Francisco Oakland Bay Self Anchored Suspension Bridge, at Zhenhua Port Mach

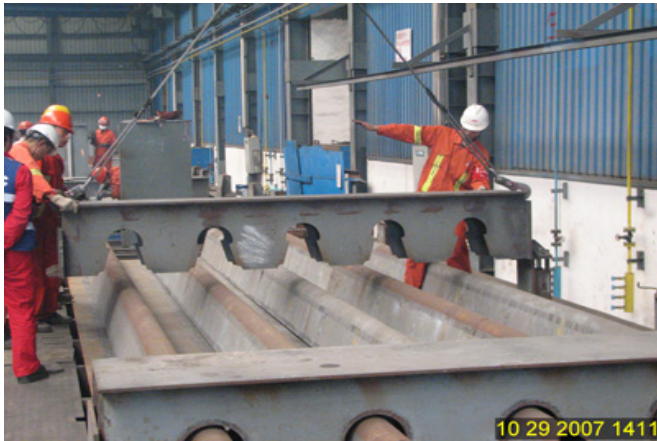
At conclusion of dimensional measurements the closed rib were moved to the deck plate at fit-up station. The following picture illustrates closed ribs being moved to welding station after dimensional verification.

Caltrans QA Inspector observed that dimensional testing appeared to be in general conformance with AWS D1.5 2002 requirements.
